Report on Concordia Humana Assessment of Waste Management at Public Health Facilities in Douala, Cameroon

Feb. 19-23, 2018

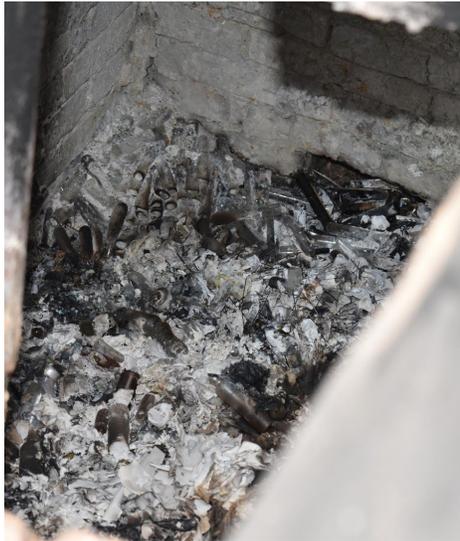
The incinerator is sited at the rear of the hospital compound in a ca. 6 m x 6 m dirt area between the facility wall and three buildings, one of which was in the final stages of construction at time of visit. There was laundry being dried on a building opposite and fruit (banana) trees immediately outside the facility wall, as well as what appeared to be papaya trees growing from the waste pile itself. The incinerator itself is constructed of brick, has a ca. 2 m chimney, and is covered by a partly collapsed awning. The incinerator appeared to be crumbling, with the top and part of a wall collapsed inside. The incinerator was full of partially burnt waste/ash with distinguishable needles, vials, and glass fragments. The area surrounding the

incinerator was strewn with uncovered and uncontained infectious waste including swabs, needles, and test tubes. There were glass fragments and needle caps (presumed needles as well) in the dirt surrounding the incinerator pad. The ash pit was ca. 3 m from the incinerator and contained a large amount of recognizable debris e.g. test tubes, presumably comparable to the ash in the incinerator.

The area separating the incinerator and ash pit was strewn with a mix of infectious waste and construction debris such as a refrigerator, plaster buckets, a bed frame, etc. There seemed to be no effort made to segregate this debris from the poorly-contained infectious waste. The poor segregation effectively undoes the extensive effort put in to waste segregation earlier in the process.
